**Flood Control Project Maintenance  
Levee Inspections**  
**LMA District Cover Sheet**  
**Spring 2019 Levee Inspection Results**

**Lake County Watershed Protection District**

**Spring 2019 Levee Inspection Results**

Waterway			Bank	Unit Miles
Unit No. 01 Middle Creek			Left	3.35
	Spring (March - May)	Summer (June - August)	(September - November) Fall	Winter (December - February)
Unit Maintenance Rating (Fall Only)				
Date of Inspection	4/11/2019 - 5/24/2019			
DWR Inspector	Luz Dial			
Accompanied By	Scott Webb Lake County			
	James Davis Lake County			
	Saskia Dononvan DWR

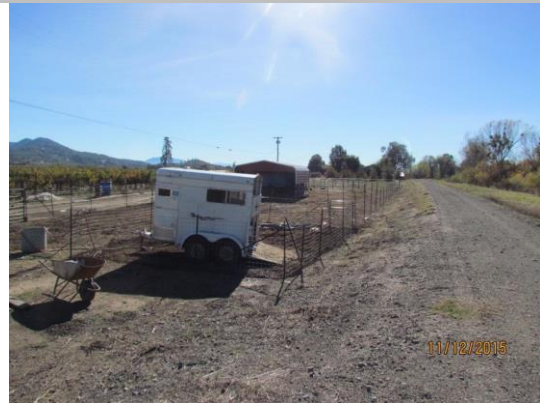
Photo 1 of 1 : SP\_2019\_NA0009\_3\_24\_20190411\_00012.jpg

LM Start	0.14	Rating **	M	Issue No.	24
LM End	0.18	Issue Type +	En	Location *	LS
Category	Earthen Levee			GPS Latitude/Longitude	
				Start	End
Item	Encroachments			39.188465 °	39.187905 °
				-122.907687 °	-122.907817 °
DWR ID	DWR_NA0009_01_f_2015_24				
Comment Code					
FE : Fence					
Inspector Comment					
Remove the fence from the landside toe.

View of the fence along the landside toe.

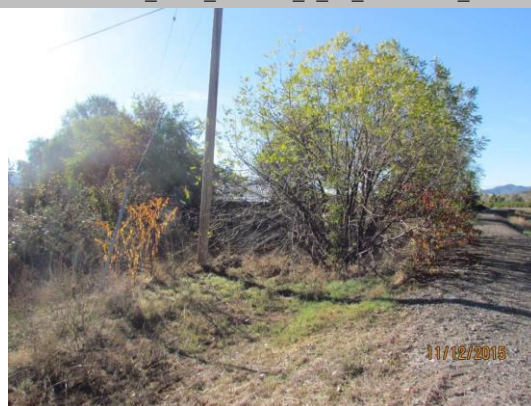
Photo 1 of 1 : SP\_2019\_NA0009\_3\_11\_20190411\_00006.jpg

LM Start	0.26	Rating **	M	Issue No.	11
LM End	0.26	Issue Type +	Ma	Location *	LS
Category	Earthen Levee			GPS Latitude/Longitude	
				Start	End
Item	Trim / Thin Trees			39.186777 °	39.186777 °
				-122.908102 °	-122.908102 °
DWR ID	DWR_NA0009_01_s_2013_11				
Comment Code					
T3 : Trim and thin trees to allow visibility of the ground and room to flood fight.					
Inspector Comment

View of the overgrown trees at the landside slope.

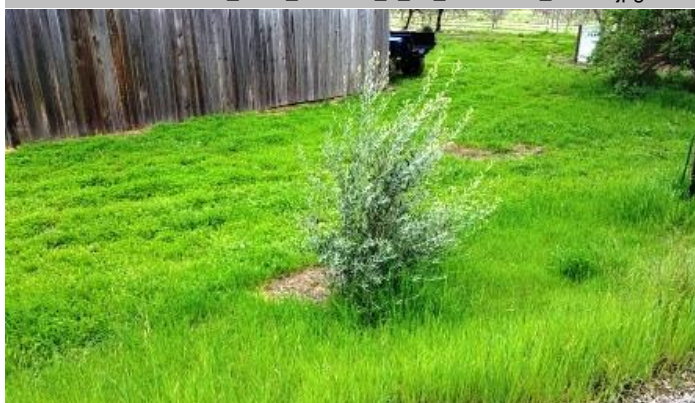
Photo 1 of 2 : SP\_2019\_NA0009\_3\_34\_20190415\_00036.jpg

LM Start	0.30	Rating **	M	Issue No.	34
LM End	0.30	Issue Type +	En	Location *	LS
Category	Earthen Levee			GPS Latitude/Longitude	
				Start	End
Item	Encroachments			39.186306 °	39.186306 °
				-122.908376 °	-122.908376 °
DWR ID	DWR_NA0009_01_s_2019_34				
Comment Code					
CR : Crops					
Inspector Comment					
Landowner needs to remove newly planted trees from levee toe easement.

View of newly planted trees within landside toe easement. Spring 2019

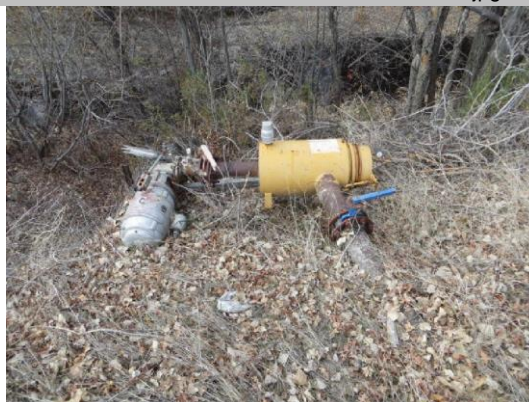
Photo 3 of 3 : UCIP\_SP\_2019\_26946\_49787.jpg

Comment Code						
Inspector Comment						
FS_ID:26946						
DS_ID:21196						
EP_NO: N/A						
Repair Type: Non-Urgent						
Crossing Status: Found						
UCIP Comments: Pump and pipe appear abandoned and should be done so properly.						
FIELD_STRUCT_DESC: *ABANDONED* 8-inch steel irrigation pipe through the levee, 3 feet below the crown. Siphon breaker in 24-inch corrugated metal riser unit on the landside (LS) slope. Pump on the waterside (WS) bank with a butterfly valve. Service pole on the WS berm. (Moitozo Brothers, Inc.). [Additional Reference(s): DWR Levee Log, 2005. USACE Sacramento O&M Manual 506.2, August 1961, (HLM 0.83)].						
FS Date: 1/9/2014

Pump and butterfly valve visible on WS berm.

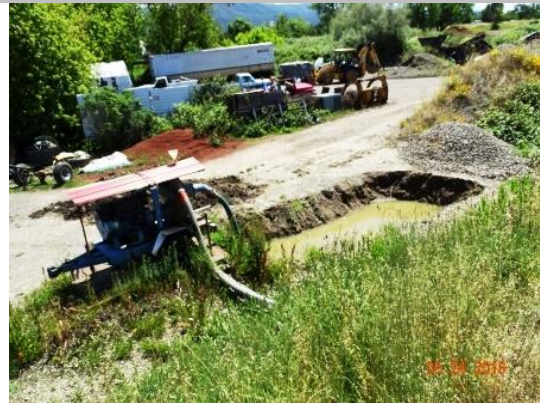
Photo 1 of 2 : SP\_2019\_NA0009\_3\_45\_20190524\_00038.jpg

LM Start	2.10	Rating **	U	Issue No.	45
LM End	2.10	Issue Type +	En	Location *	LS
Category	Earthen Levee			GPS Latitude/Longitude	
				Start	End
Item	Encroachments			39.162198 °	39.162198 °
				-122.915488 °	-122.915488 °
DWR ID	DWR_NA0009_01_s_2019_45				
Comment Code					
DT : Ditch					
Inspector Comment					
The landowner dug a pit approximately 24' x 12' x 3' within the theoretical levee prism and ran a metal pump hose over the crown.

View looking downstream at a storage pit dug into the levee prism.  
Spring 2019

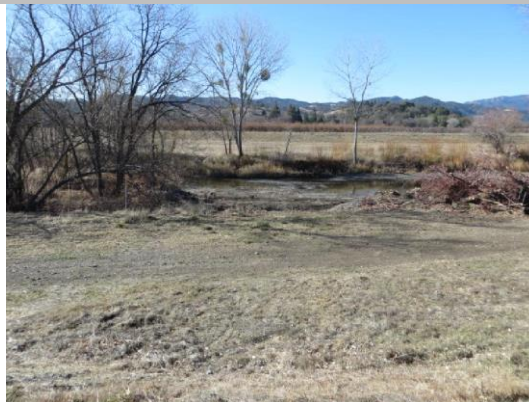
Photo 3 of 3 : UCIP\_SP\_2019\_26987\_49851.jpg

Pipe, Concrete headwall, and flap gate visible on WS berm.

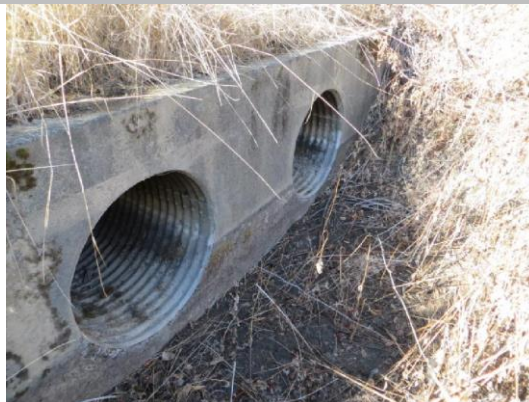
Photo 2 of 3 : UCIP\_SP\_2019\_26986\_49848.jpg

Concrete headwall and pipe visible on LS toe.

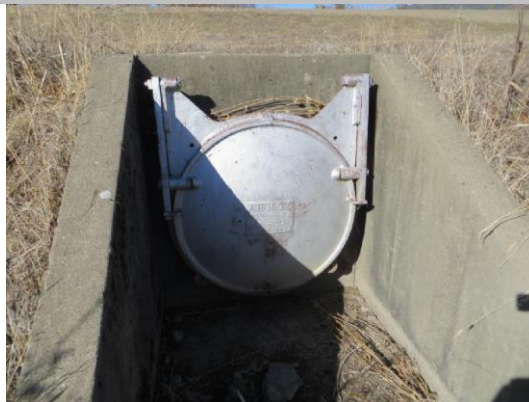
Photo 3 of 3 : UCIP\_SP\_2019\_27004\_49860.jpg

Concrete U-shaped headwall and flap gate on WS berm.

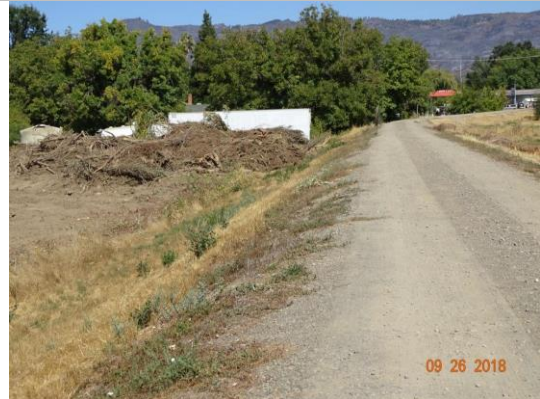
Photo 1 of 1 : SP\_2019\_NA0009\_3\_29\_20190411\_00015.jpg

LM Start	2.35	Rating **	M	Issue No.	29
LM End	2.35	Issue Type +	En	Location *	LS
Category	Earthen Levee			GPS Latitude/Longitude	
				Start	End
Item	Encroachments			39.161075 °	39.161075 °
				-122.912758 °	-122.912758 °
DWR ID	DWR_NA0009_01_f _ 2018_29				
Comment Code					
DE : Debris					
Inspector Comment					
Remove the debris from the landside toe.

View of the large amount of debris along the landside toe.

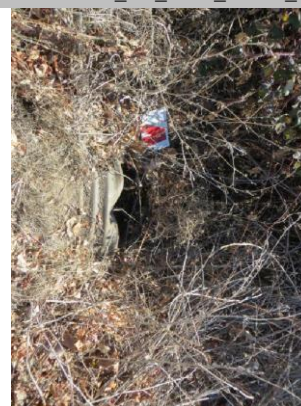
Photo 1 of 3 : UCIP\_SP\_2019\_53326\_50042.jpg

Comment Code					
Inspector Comment					
FS_ID:53326 DS_ID:21200 EP_NO: 11458 Repair Type: Urgent Crossing Status: Found UCIP Comments: 9/6/2018 Inspected this crossing per the request of LMA Rep, Scott Webb. WS pipe does not have a WS closure device and has caused flooding of the roadway due to the flat LS pipe slope and roadway. Classifying Urgent until the flooding risk is reduced by the installation of a WS gate valve (D. Sanoski - DWR UCIP). FIELD_STRUCT_DESC: 36-inch corrugated metal drainage pipe through the levee, 8 feet below the crown. 24-inch by 36-inch drainage drop inlet visible at edge of pavement on Highway 20. Open on the waterside (WS) end. (Pipe retained through the levee under Automatic Board Order (ABO) issued as Permit No. 11458, 1975 - Fernande and Guido Deghetaldi). [Additional Reference(s): DWR Levee Log, 2005]. FS Date: 9/6/2018 1:04:00 PM

Outlet visible on WS toe.

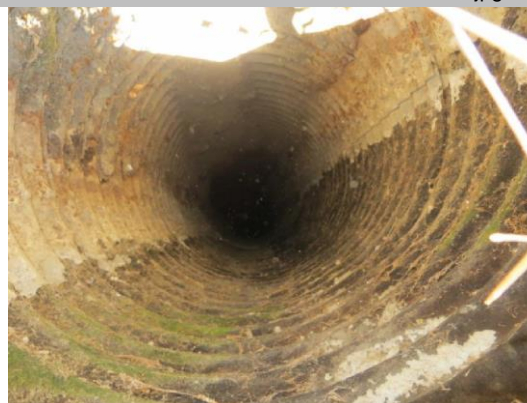
Photo 2 of 3 : UCIP\_SP\_2019\_53326\_50041.jpg

Some rust on inside of CMP pipe at WS toe.

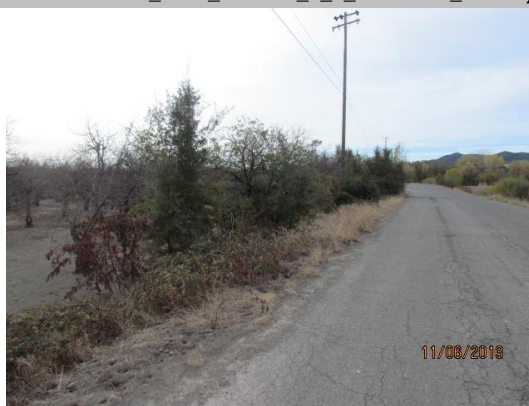
Photo 1 of 2 : SP\_2019\_NA0009\_3\_3\_20190411\_00001.jpg

LM Start	2.48	Rating **	U	Issue No.	3
LM End	2.55	Issue Type +	Ma	Location *	LS
Category	Earthen Levee			GPS Latitude/Longitude	
				Start	End
Item	Vegetation			39.161615 °	39.160804 °
				-122.911733 °	-122.912536 °
DWR ID	DWR_NA0009_01_s_2012_3				
Comment Code					
V2 : Remove the wild growth other than native grasses from the levee slopes.					
Inspector Comment					
The LMA cleared vegetation on the levee slope, but thick brush remains on the other side of the wire fence along the levee toe easement.

View of the vegetation along the landside slope.

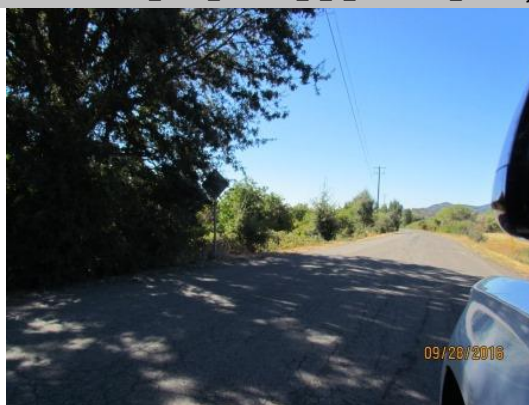
Photo 2 of 2 : SP\_2019\_NA0009\_3\_3\_20190411\_00002.jpg

View of the vegetation along the landside slope.

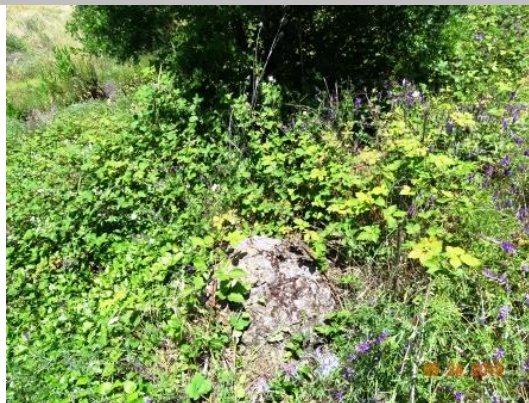
Photo 2 of 2 : SP\_2019\_NA0009\_3\_48\_20190524\_00041.jpg

LM Start	2.49	Rating **	M	Issue No.	48 (cont)	
LM End	2.49	Issue Type +	Ma	Location *	WS	
Category	Earthen Levee			GPS Latitude/Longitude		
				Start		End
Item	Animal Control			39.161472 °		39.161472 °
				-122.911822 °		-122.911822 °
DWR ID	DWR_NA0009_01_s_2019_48					
Comment Code						
A3 : No rodents visible, but rodent burrows visible; need to backfill and compact or grout burrows.						
Inspector Comment						
Backfill animal holes on both sides of the levee.

View looking upstream at animal holes on the waterside slope. Spring 2019

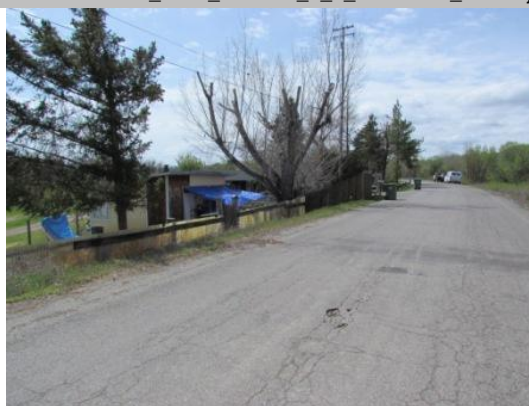
Photo 1 of 1 : SP\_2019\_NA0009\_3\_4\_20190411\_00003.jpg

LM Start	2.58	Rating **	M	Issue No.	4
LM End	2.61	Issue Type +	En	Location *	LS
Category	Earthen Levee			GPS Latitude/Longitude	
				Start	End
Item	Encroachments			39.160398 °	39.160020 °
				-122.912837 °	-122.913186 °
DWR ID	DWR_NA0009_01_s_2012_4				
Comment Code					
FE : Fence					
Inspector Comment

View of the fences at the Landside toe.

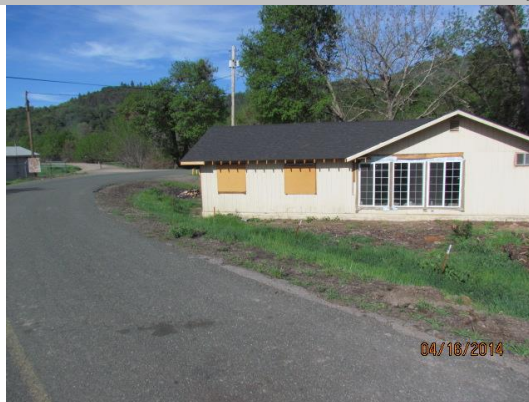
Photo 1 of 1 : SP\_2019\_NA0009\_4\_1\_20190411\_00001.jpg

LM Start	0.20	Rating **	U	Issue No.	1
LM End	0.20	Issue Type +	En	Location *	LS
Category	Earthen Levee			GPS Latitude/Longitude	
				Start	End
Item	Encroachments			39.187039 °	39.187039 °
				-122.908880 °	-122.908880 °
DWR ID	DWR_NA0009_02_s_2016_1				
Comment Code					
BU : Building					
Inspector Comment

View of the building on the landside toe.

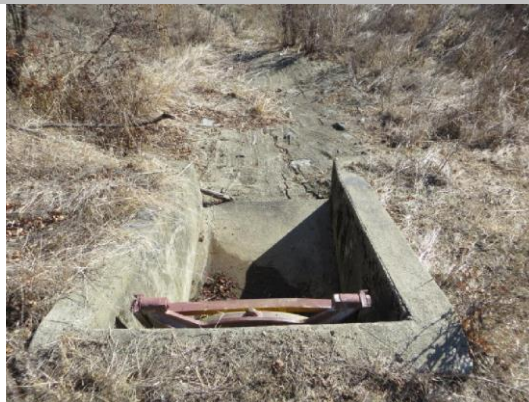
Photo 3 of 3 : UCIP\_SP\_2019\_27184\_50320.jpg

Flapgate and concrete headwall on WS toe.

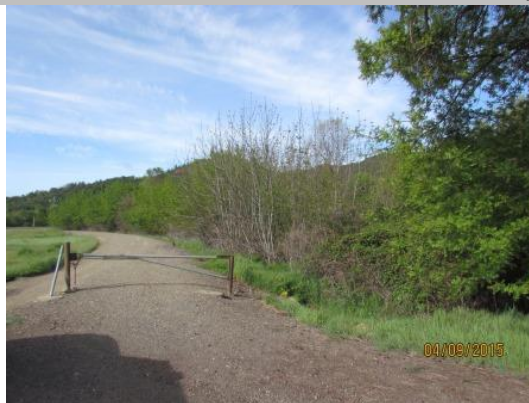
Photo 1 of 1 : SP\_2019\_NA0009\_4\_9\_20190411\_00005.jpg

LM Start	0.24	Rating **	M	Issue No.	9
LM End	0.27	Issue Type +	Ma	Location *	LS
Category	Earthen Levee			GPS Latitude/Longitude	
				Start	End
Item	Trim / Thin Trees			39.186739 °	39.186389 °
				-122.909436 °	-122.909821 °
DWR ID	DWR_NA0009_02_s_2013_9				
Comment Code					
T1 : Trim trees to at least five feet above ground level.					
Inspector Comment

View of the overgrown trees and vegetation at the landside toe.

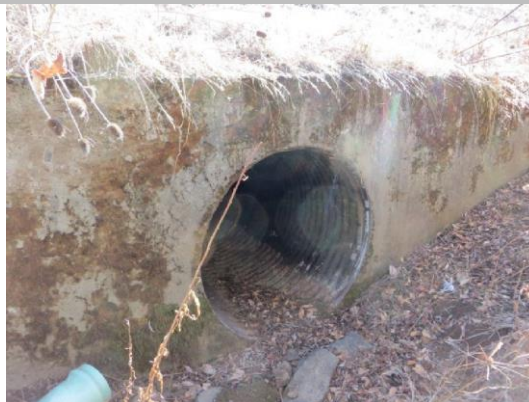
Photo 3 of 3 : UCIP\_SP\_2019\_27192\_50324.jpg

Pipe and concrete headwall at LS toe.

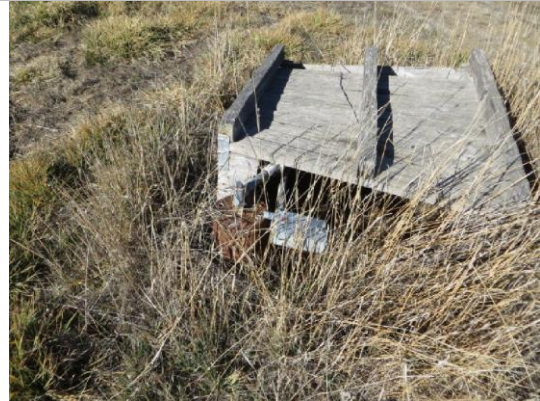
Photo 1 of 3 : UCIP\_SP\_2019\_52935\_50393.jpg

LM Start	<b>0.50</b>	Rating **	M	Issue No.	<b>45 (cont)</b>
LM End	<b>0.50</b>	Issue Type +	En	Location *

Pump and pipe visible at wooden box on WS berm.

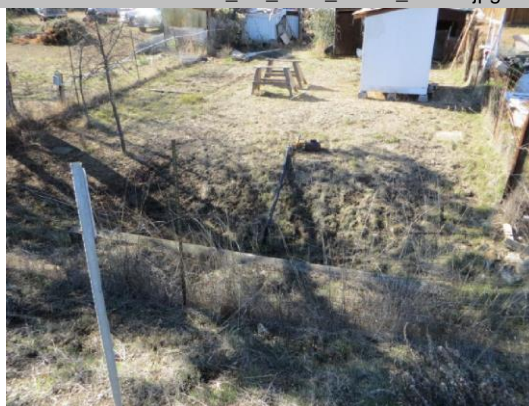
Photo 1 of 3 : UCIP\_SP\_2019\_27208\_50411.jpg

Concrete headwall on LS toe.

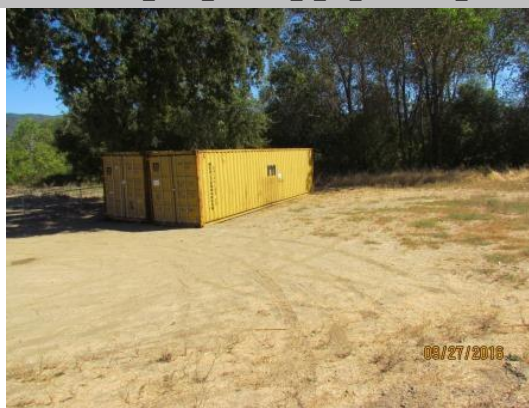
Photo 1 of 1 : SP\_2019\_NA0009\_4\_25\_20190411\_00010.jpg

LM Start	0.96	Rating **	M	Issue No.	25
LM End	0.96	Issue Type +	En	Location *	WS
Category	Earthen Levee			GPS Latitude/Longitude	
				Start	End
Item	Encroachments			39.177249 °	39.177249 °
				-122.913619 °	-122.913619 °
DWR ID	DWR_NA0009_02_f_2016_25				
Comment Code					
BU : Building					
Inspector Comment					
Two 40' shipping containers in the flood way need to be removed.

View of the shipping container in the floodway.

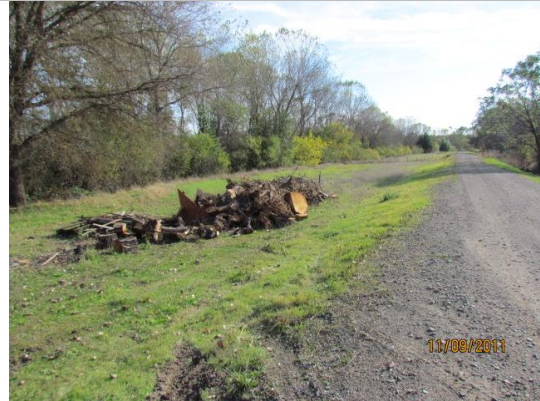
Photo 1 of 1 : SP\_2019\_NA0009\_4\_3\_20190411\_00003.jpg

LM Start	0.99	Rating **	M	Issue No.	3
LM End	0.99	Issue Type +	Ma	Location *	WS
Category	Earthen Levee			GPS Latitude/Longitude	
				Start	End
Item	Encroachments			39.176835 °	39.176835 °
				-122.913558 °	-122.913558 °
DWR ID	DWR_NA0009_02_s_2012_3				
Comment Code					
TR : Tree or limb					
Inspector Comment

View of the tree prunings on the W/S toe.

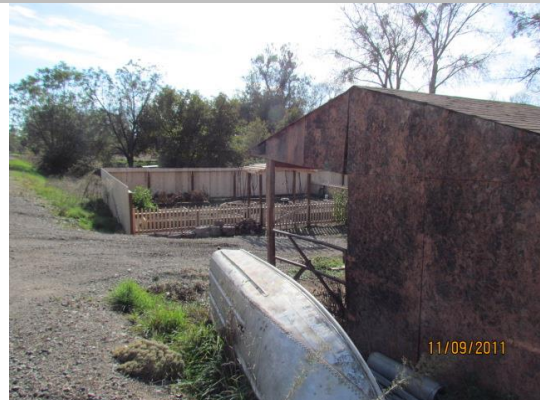
Photo 1 of 1 : SP\_2019\_NA0009\_4\_2\_20190411\_00002.jpg

LM Start	0.99	Rating **	U	Issue No.	2
LM End	0.99	Issue Type +	En	Location *	LS
Category	Earthen Levee			GPS Latitude/Longitude	
				Start	End
Item	Encroachments			39.176815 °	39.176815 °
				-122.913540 °	-122.913540 °
DWR ID	DWR_NA0009_02_s_2012_2				
Comment Code					
FE : Fence					
Inspector Comment					
Unpermitted fence and building.

View of the building &amp; fence along the landside toe.

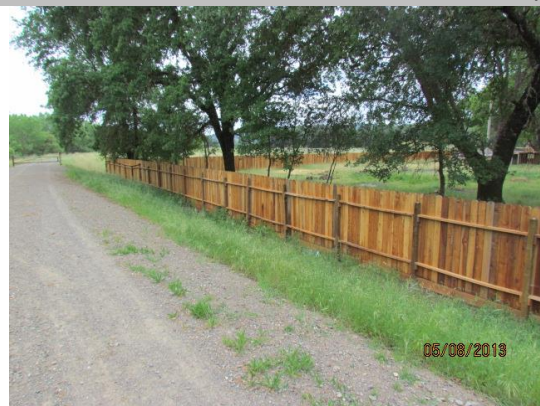
Photo 1 of 1 : SP\_2019\_NA0009\_4\_10\_20190411\_00006.jpg

LM Start	1.09	Rating **	U	Issue No.	10
LM End	1.11	Issue Type +	En	Location *	LS
Category	Earthen Levee			GPS Latitude/Longitude	
				Start	End
Item	Encroachments			39.175460 °	39.175075 °
				-122.913400 °	-122.913392 °
DWR ID	DWR_NA0009_02_s_2013_10				
Comment Code					
FE : Fence					
Inspector Comment

View of the unauthorized fence along the landside toe. Spring 2013

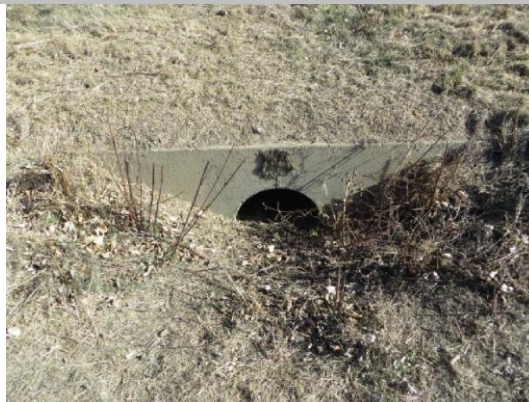
Photo 3 of 3 : UCIP\_SP\_2019\_27630\_51281.jpg

Concrete headwall and pipe visible at LS toe.

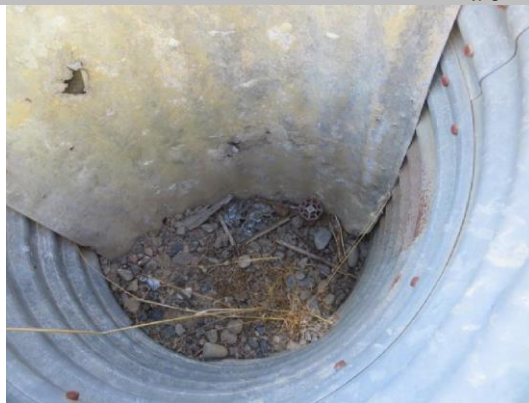
Photo 1 of 3 : UCIP\_SP\_2019\_27891\_51587.jpg

Valve visible at bottom of CMP riser on LS shoulder.

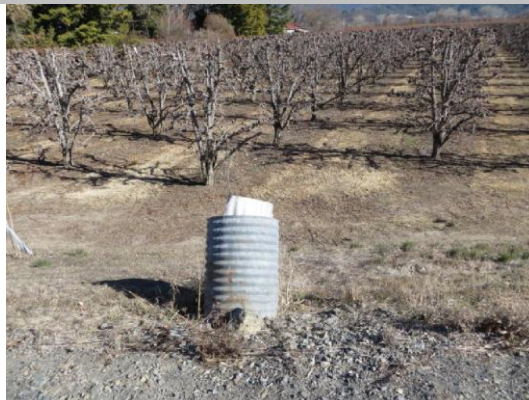
Photo 2 of 3 : UCIP\_SP\_2019\_27891\_51586.jpg

Siphon at LS shoulder inside 24-inch CMP riser.

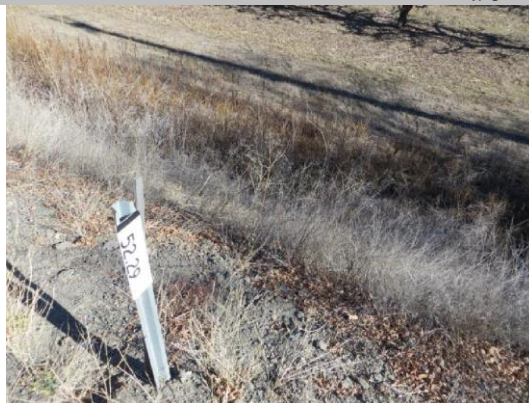
Photo 2 of 3 : UCIP\_SP\_2019\_27893\_51594.jpg

Roadway marker 52.29 on LS and WS shoulder mark pipe location on crown.

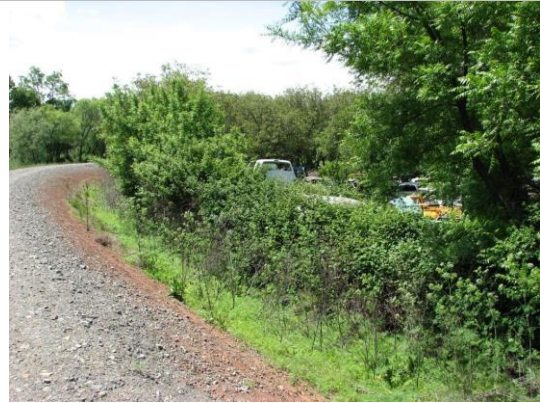
Photo 1 of 1 : SP\_2019\_NA0009\_5\_12\_20190411\_00003.jpg

LM Start	0.93	Rating **	U	Issue No.	12
LM End	1.13	Issue Type +	Ma	Location *	LS
Category	Earthen Levee			GPS Latitude/Longitude	
				Start	End
Item	Vegetation			39.159778 °	39.159616 °
				-122.921140 °	-122.924645 °
DWR ID	DWR_NA0009_03_s_2016_12				
Comment Code					
V2 : Remove the wild growth other than native grasses from the levee slopes.					
Inspector Comment					
Dense vegetation growing on fence blocks visibility and access.

5/2/2016: Dense bushes and vines covering fence along vehicle junk yard.

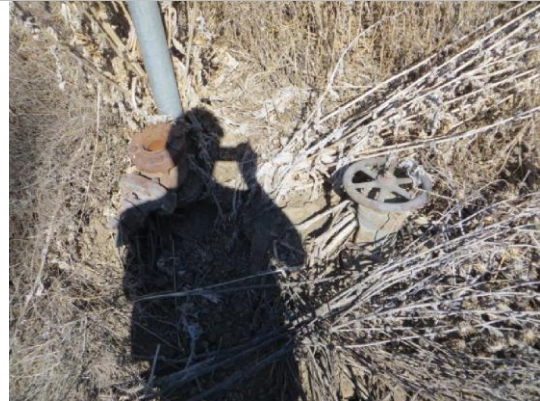
Photo 2 of 3 : UCIP\_SP\_2019\_27903\_51621.jpg

Gate valves at tank appear to be in disrepair.

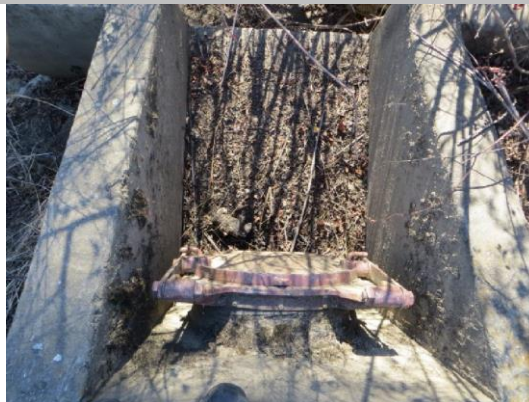
Photo 2 of 3 : UCIP\_SP\_2019\_27943\_51641.jpg

Headwall and flapgate on WS berm.

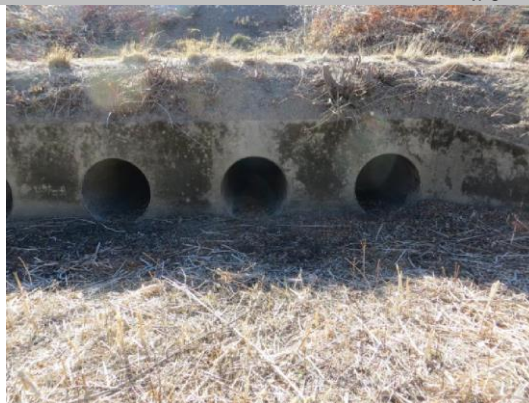
Photo 1 of 3 : UCIP\_SP\_2019\_27965\_51668.jpg

Pipe and concrete headwall on LS toe.

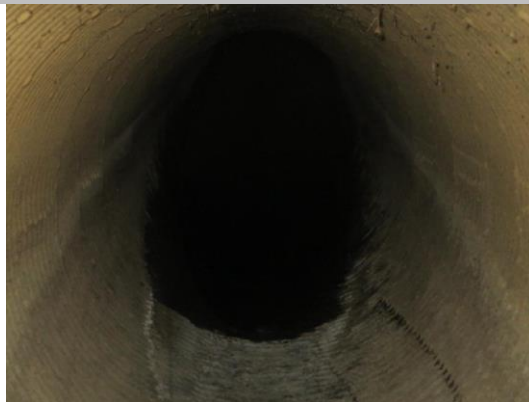
Photo 2 of 3 : UCIP\_SP\_2019\_27965\_51667.jpg

Pipe from LS toe.

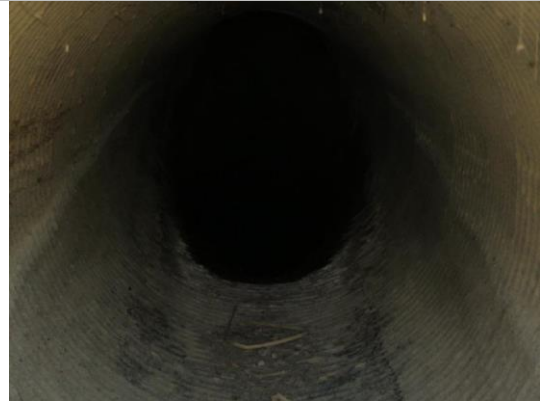
Photo 2 of 3 : UCIP\_SP\_2019\_27967\_51670.jpg

Pipe from LS toe.

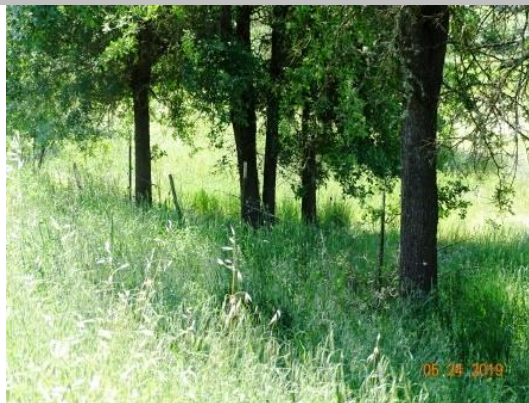
Photo 1 of 1 : SP\_2019\_NA0009\_5\_26\_20190524\_00043.jpg

LM Start	1.25	Rating **	M	Issue No.	26
LM End	1.34	Issue Type +	En	Location *	WS
Category	Earthen Levee			GPS Latitude/Longitude	
				Start	End
Item	Encroachments			39.160532 °	39.161265 °
				-122.926523 °	-122.927877 °
DWR ID	DWR_NA0009_03_s_2019_26				
Comment Code					
FE : Fence					
Inspector Comment					
Barbed wire fence along the waterside toe does not appear to be permitted.

View looking downstream at wire fence along the levee toe. Spring 2019

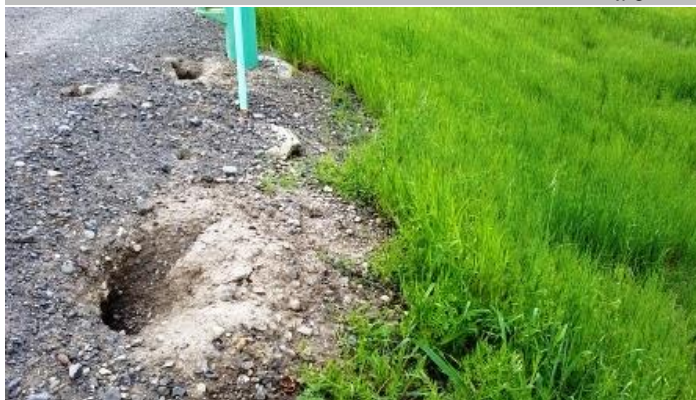
Photo 1 of 1 : SP\_2019\_NA0009\_6\_26\_20190415\_00024.jpg

LM Start	1.04	Rating **	M	Issue No.	26
LM End	1.04	Issue Type +	Ma	Location *	LS
Category	Earthen Levee			GPS Latitude/Longitude	
				Start	End
Item	Animal Control			39.180440 °	39.180440 °
				-122.896638 °	-122.896638 °
DWR ID	DWR_NA0009_04_s_2019_26				
Comment Code					
A1 : Exterminate rodents and backfill and compact or grout burrows.					
Inspector Comment

View of rodent holes near the gate with animal activity. Spring 2019

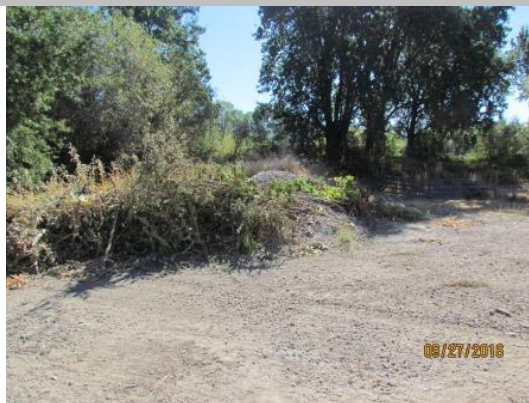
Photo 1 of 1 : SP\_2019\_NA0009\_6\_10\_20190411\_00002.jpg

LM Start	1.42	Rating **	M	Issue No.	10
LM End	1.42	Issue Type +	En	Location *	WS
Category	Earthen Levee			GPS Latitude/Longitude	
				Start	End
Item	Encroachments			39.185074 °	39.185074 °
				-122.893382 °	-122.893382 °
DWR ID	DWR_NA0009_04_f_2016_10				
Comment Code					
DE : Debris					
Inspector Comment

View of the prunings and soil pile on the waterside berm looking downstream.

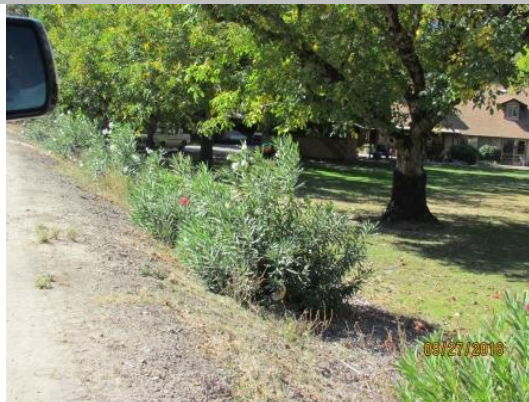
Photo 1 of 1 : SP\_2019\_NA0009\_6\_4\_20190411\_00001.jpg

LM Start	1.43	Rating **	M	Issue No.	4
LM End	1.46	Issue Type +	En	Location *	LS
Category	Earthen Levee			GPS Latitude/Longitude	
				Start	End
Item	Vegetation			39.185183 °	39.185568 °
				-122.893384 °	-122.893348 °
DWR ID	DWR_NA0009_04_f_2016_4				
Comment Code					
V6 : Landscaping					
Inspector Comment					
Oleanders blocking visibility need to be trimmed.

View of the Oleanders looking downstream. Fall 2016

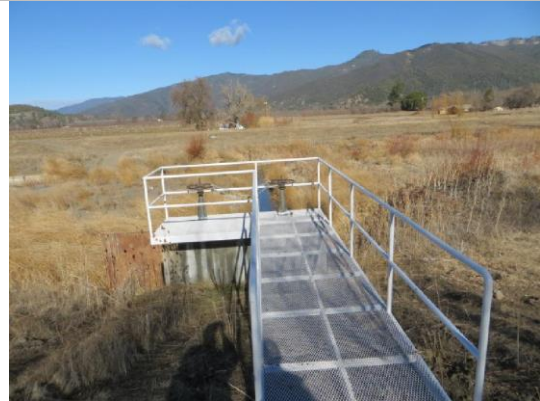
Photo 1 of 3 : UCIP\_SP\_2019\_26897\_49712.jpg

Slide gate at steel walkway on WS toe.

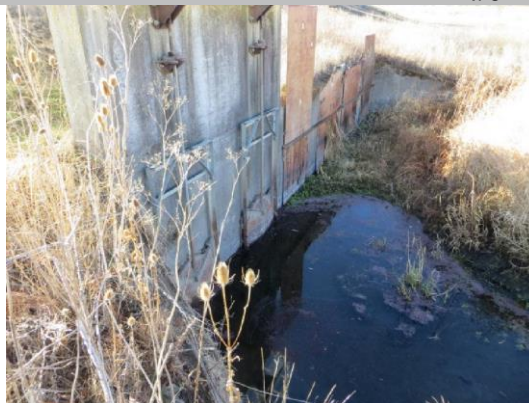
Photo 3 of 3 : UCIP\_SP\_2019\_26897\_49710.jpg

Slide gate at concrete headwall on WS toe.

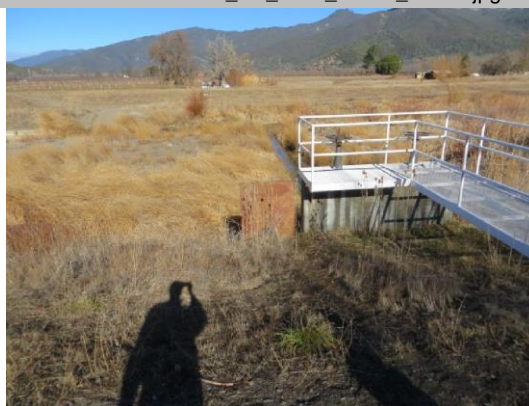
Photo 1 of 3 : UCIP\_SP\_2019\_26885\_49634.jpg

Steel plate slide gate visible at headwall on WS toe.

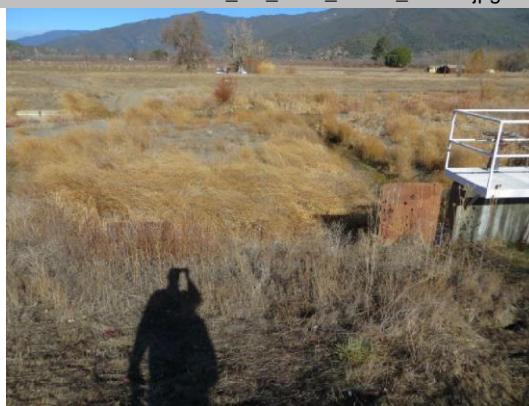
Photo 1 of 3 : UCIP\_SP\_2019\_26883\_49622.jpg

Metal slide gate visible at concrete headwall on WS toe.

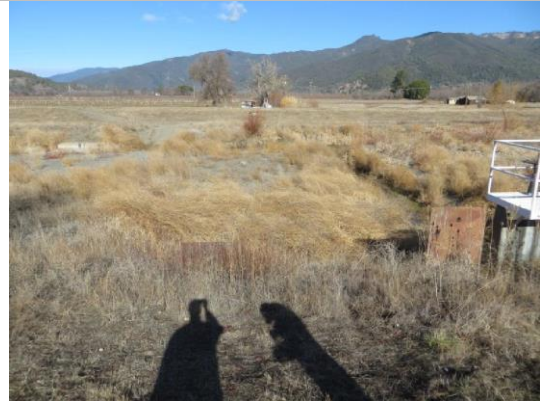
Photo 1 of 3 : UCIP\_SP\_2019\_26877\_49610.jpg

Steel slide gate visible at headwall on WS toe.

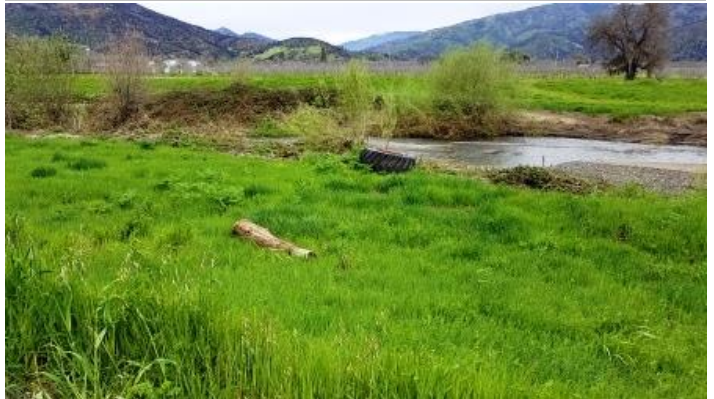
Photo 1 of 1 : SP\_2019\_NA0009\_7\_17\_20190415\_00029.jpg

LM Start	0.33	Rating **	M	Issue No.	17
LM End	0.33	Issue Type +	Ma	Location *	WS
Category	Earthen Levee			GPS Latitude/Longitude	
				Start	End
Item	Encroachments			39.176973 °	39.176973 °
				-122.899228 °	-122.899228 °
DWR ID	DWR_NA0009_05_s _ 2019_17				
Comment Code					
DE : Debris					
Inspector Comment					
Remove tree log and large tire in the waterway.

View of large tire and tree log in the waterway. Spring 2019

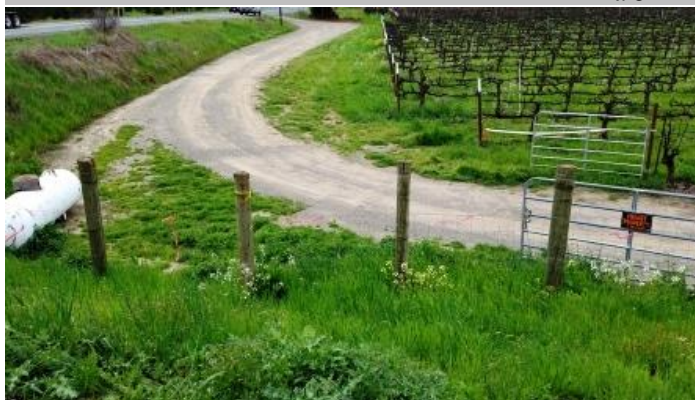
Photo 1 of 1 : SP\_2019\_NA0009\_7\_23\_20190415\_00028.jpg

LM Start	0.55	Rating **	M	Issue No.	23
LM End	0.55	Issue Type +	En	Location *	LS
Category	Earthen Levee			GPS Latitude/Longitude	
				Start	End
Item	Encroachments			39.175702 °	39.175702 °
				-122.902881 °	-122.902881 °
DWR ID	DWR_NA0009_05_s _ 2019_23				
Comment Code					
EQ : Equipment					
Inspector Comment					
Remove propane tank from levee toe easement.

View of propane tank located at levee toe. Spring 2019

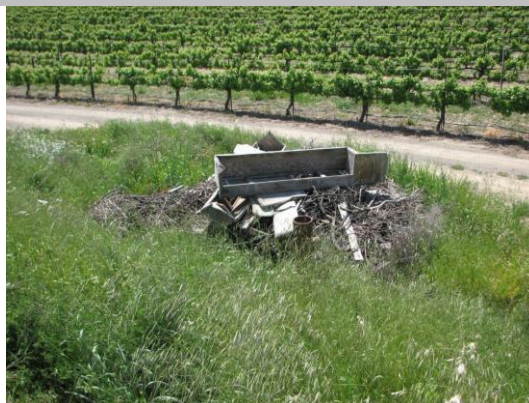
Photo 1 of 1 : SP\_2019\_NA0009\_7\_10\_20190411\_00001.jpg

LM Start	0.63	Rating **	M	Issue No.	10
LM End	0.63	Issue Type +	En	Location *	LS
Category	Earthen Levee			GPS Latitude/Longitude	
				Start	End
Item	Encroachments			39.175758 °	39.175758 °
				-122.904353 °	-122.904353 °
DWR ID	DWR_NA0009_05_s _ 2016_10				
Comment Code					
DE : Debris					
Inspector Comment					
Remove prunings and wooden lumber debris.

5/2/2016: Remove prunings and lumber debris from L/S toe.
